[Docket No. FAA-2018-0479; Product Identifier 2016-NE-23-AD]

Airworthiness Directives; Honeywell International Inc. Turboprop and Turboshift Engines

ACTION: Notice of proposed rulemaking (NPRM).

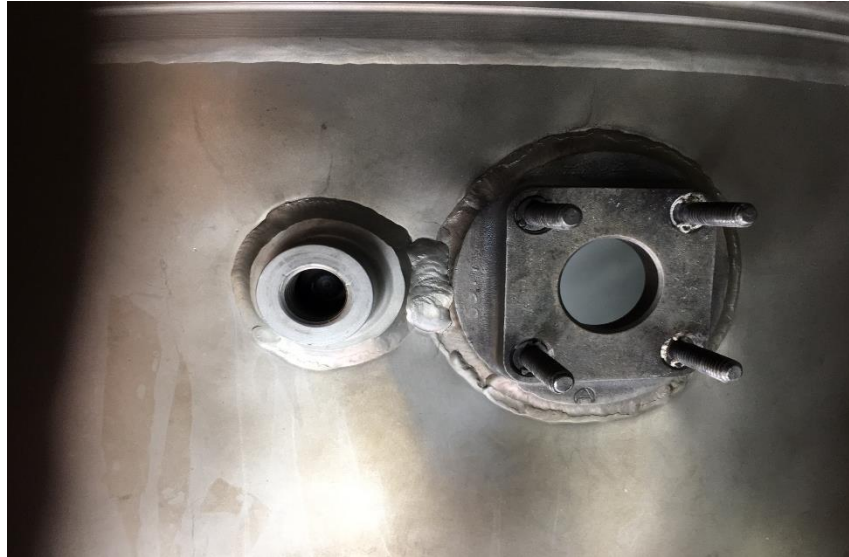
**Figure 1 to Paragraph (h) of this AD. Combustion Chamber Case Assembly
Without the One-Piece Bleed Pad with P3 Boss**

(2) Figures 1 and 2 to paragraph (h) of this AD illustrate the appearance of combustion chamber case assembly, P/N 893973-5, without and with, respectively, the one-piece bleed pad with the P3 boss.

(2) For TPE331-3U, -3UW, -5, -5A, -5AB, -5B, -6, and -6A engine models with combustion chamber case assemblies, P/Ns 869728-1, 869728-3, or 893973-5, installed, and without the one-piece bleed pad with P3 boss; and for TPE331-1, -2, and -2UA engine models modified by National Flight Services, Inc., supplemental type certificate (STC) SE383CH, remove the combustion chamber case assembly from service at the next removal of the combustion chamber case assembly from the engine, not to exceed 3,700 hours TIS since last hot section inspection.

After the effective date of this AD, do not install a combustion chamber case assembly, P/N 869728-1, 869728-3, or 893973-5, in TPE331-3U, -3UW, -5, -5A, -5AB, -5B, -6, and -6A engine models or in TPE331-1, -2, and -2UA engine models modified by National Flight Services, Inc., STC SE383CH, unless the combustion chamber case assembly has a one-piece bleed pad with P3 boss.
